VI INTERNATIONAL TUNNELING FORUM

Silkyara Tunnel Rescue **A Tale of Resilience, Innovation and Survival**

Rahul Gupta
Chief Engineer
Ministry of Road Transport & Highways
Government of India

14th May, 2024

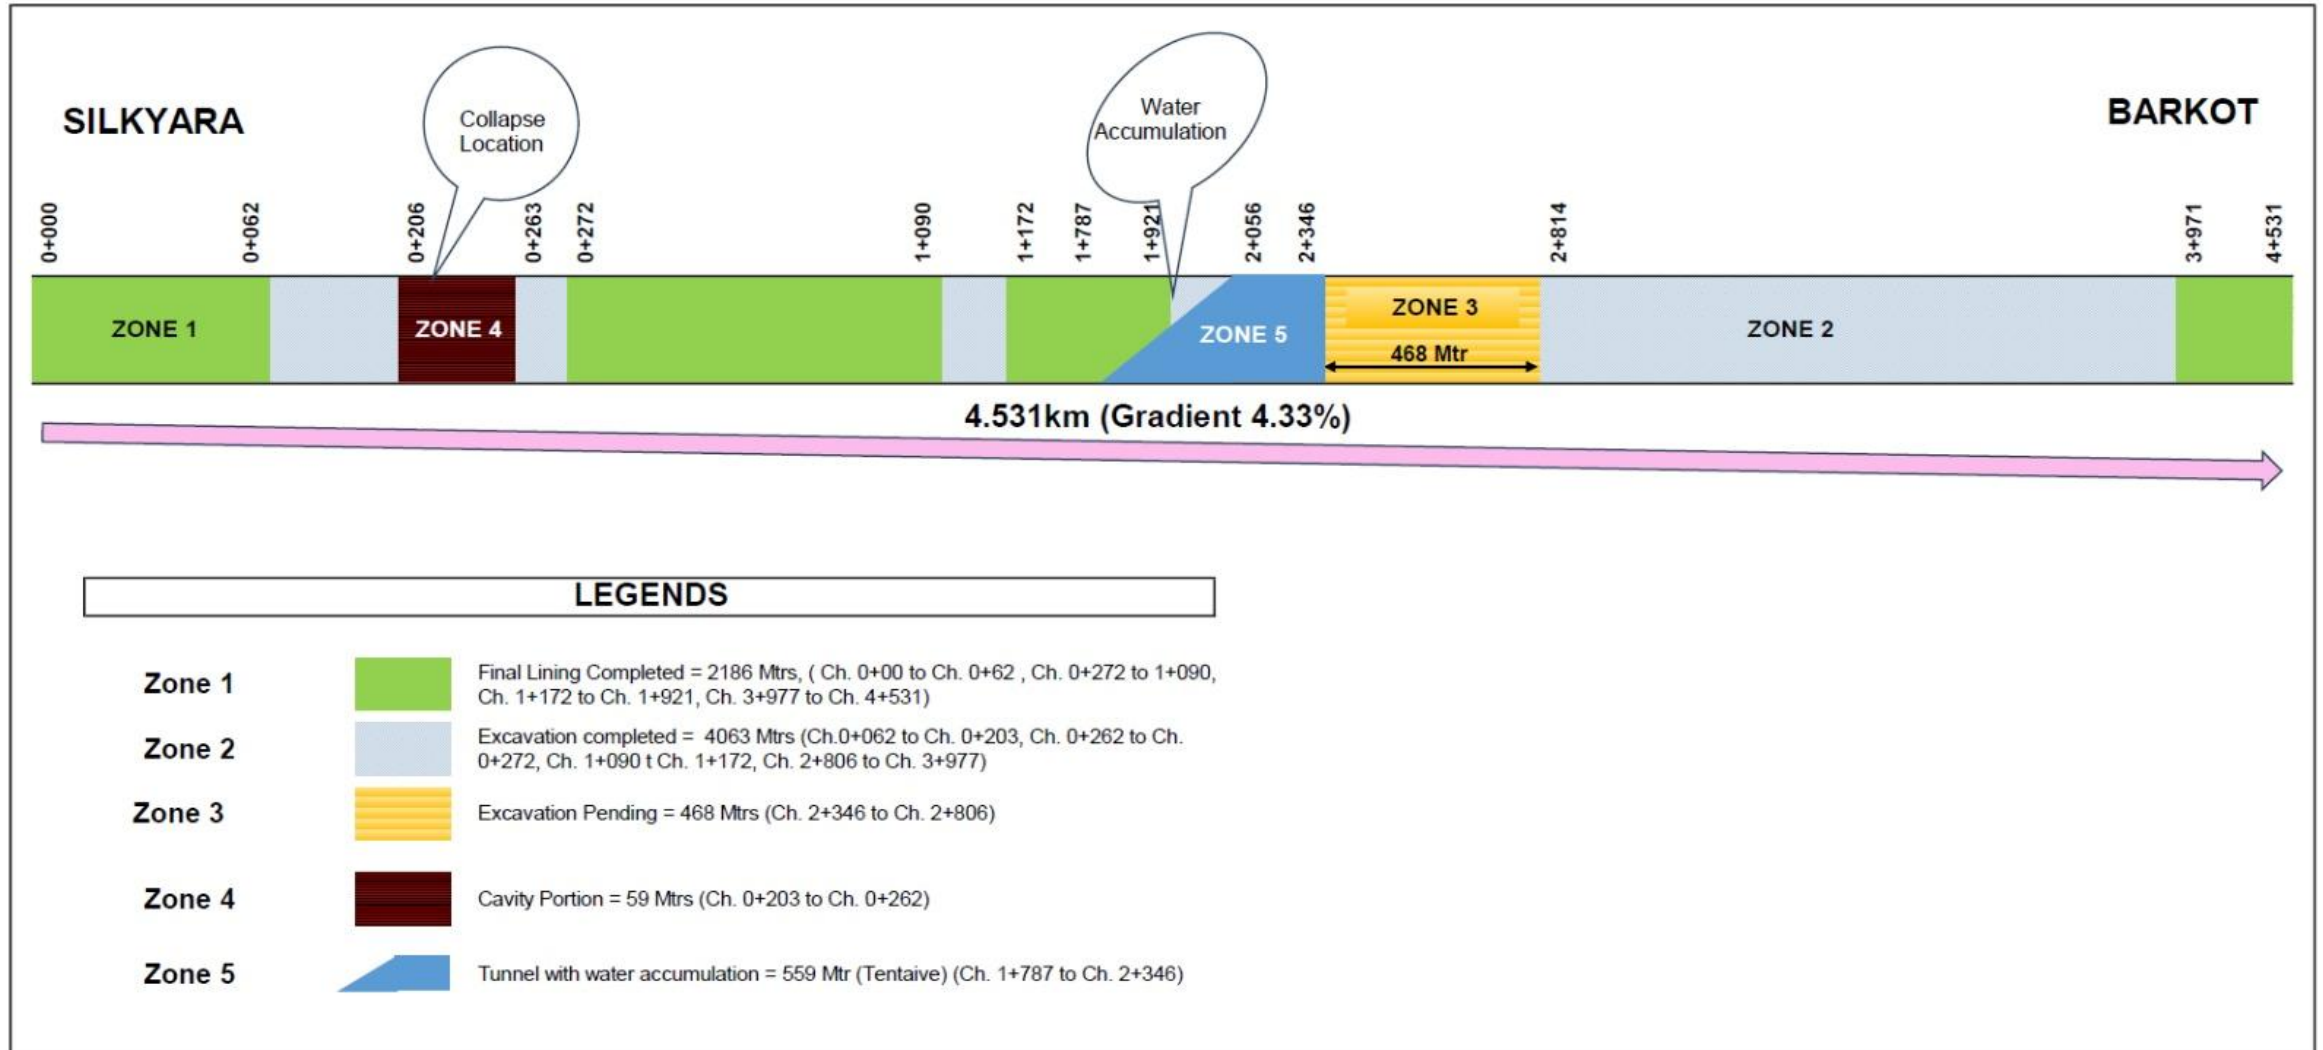
Zone Wise Schematic Diagram of Silkyara Tunnel

Physical evidences of collapse b/w Ch. 205 to 260 from Sylkyara end.

1. Highly pulverized fine grade material flown out of the crown: high in silica and silt content which indicates towards metamorphosed siltstones, Phyllites and sills trapped out of dykes.
2. Complete disintegration of supports viz. lattice girders, bolts, pipes etc.
3. No flowing groundwater encountered.
4. Collapse in shear zone in the contact region of meta siltstones and amphibolites.
5. Such large shear zones are natural to occur in the Himalayan geology especially given the seismo-tectonic set up of the region

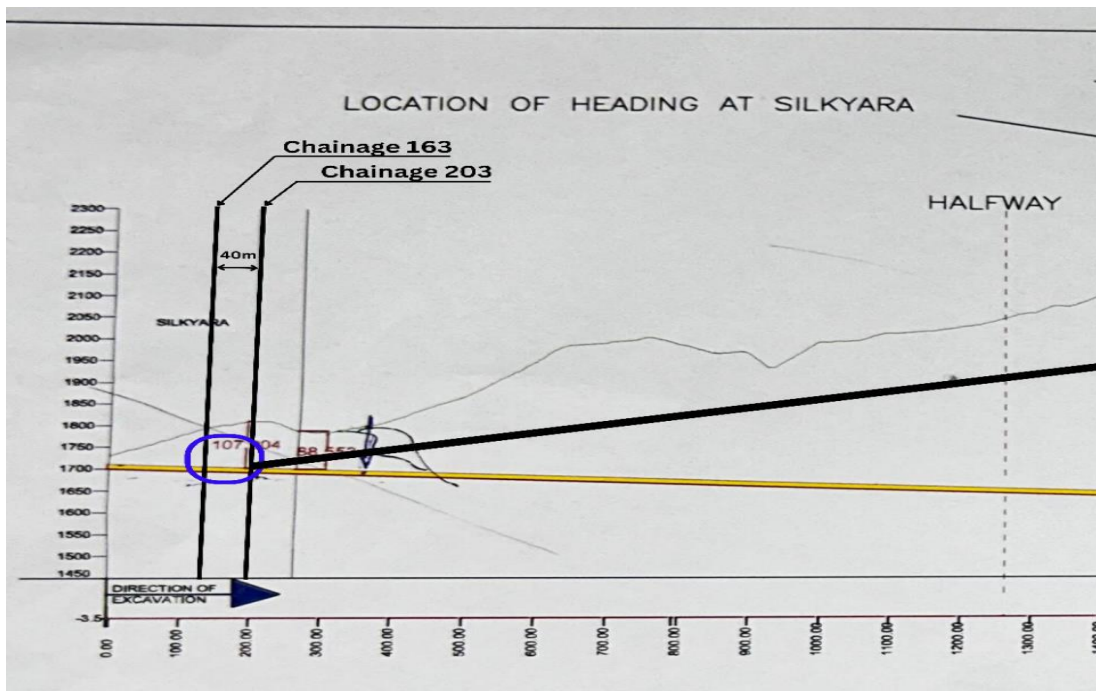
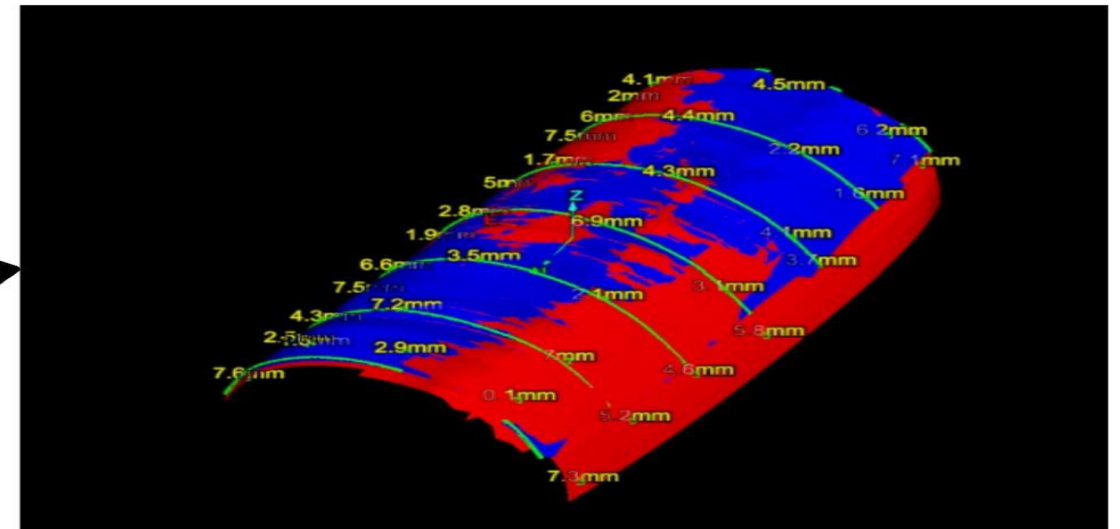
Change Detection Report

Using Drone-based LiDAR: Change detection mapping involves superimposing scans taken on various days with the same Ground Control Points (GCP) and simulating the results to calculate the average maximum displacement.

The initial scan performed on 22/11/2023; subsequent scans conducted on 23/11/2023. Average maximum displacement observed is approximately 7mm over a 12-hour interval.

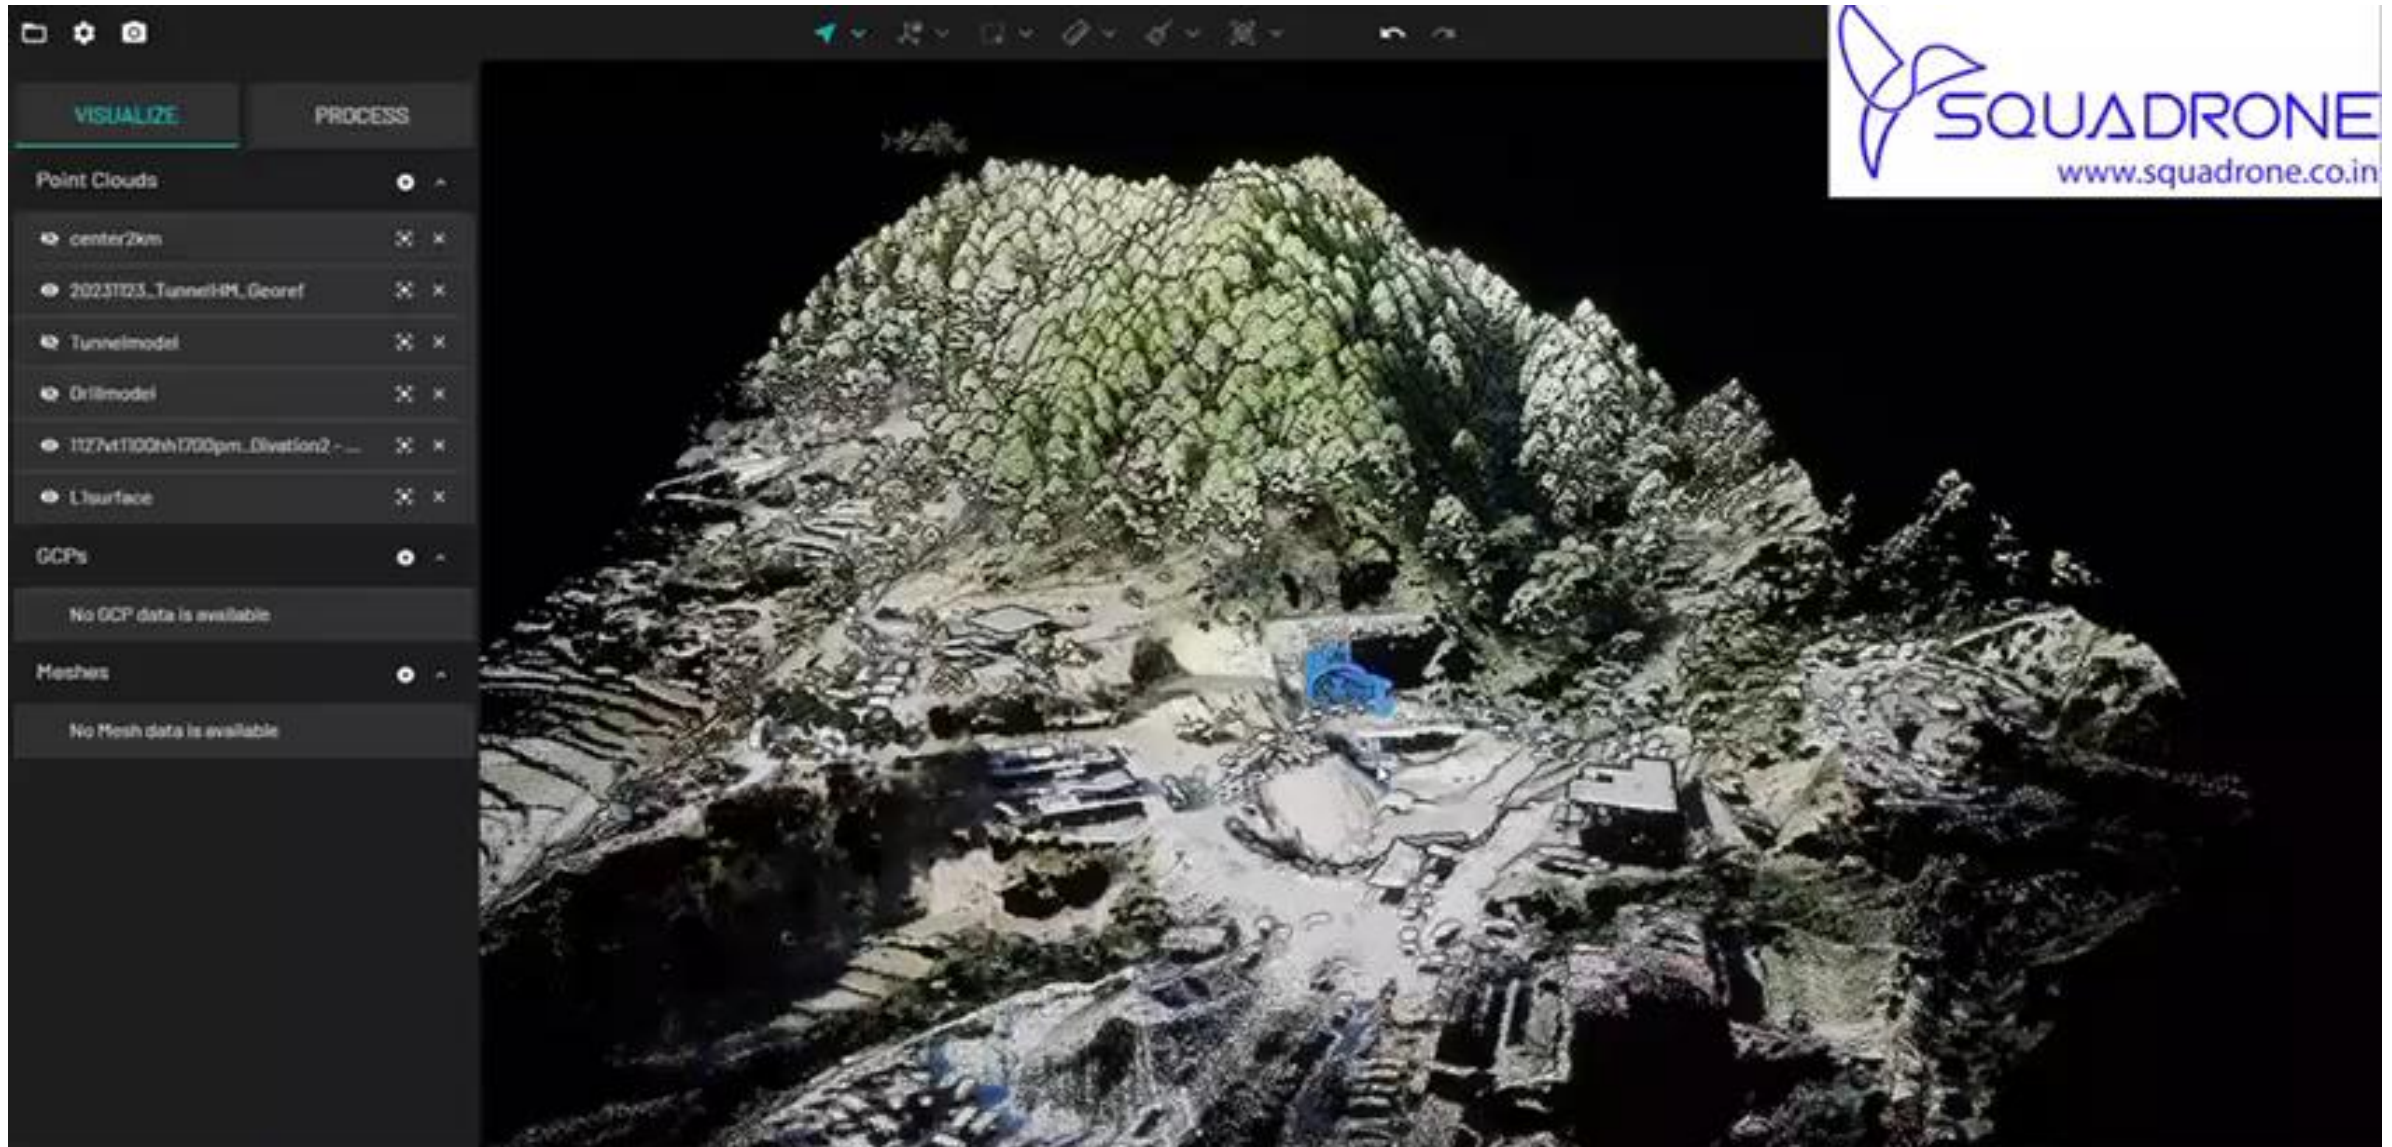
LIDAR based 3D Mapping

Sl No:	Section at Chainage	Displacement in B/W Scan 3- 24/11/2023 at 02:00 AM & Scan 4 - 25/11/2023 at 03:00PM	
		Minimum	Maximum
1	203	0.1	17.3
2	193	2.5	18.2
3	183	2.1	18.6
4	173	1.9	16.9
5	163	1.7	17.9
6	153	1.6	18.2
7	143	2	15.9
8	133	0.6	17.2
9	123	1.2	16.2
10	113	1.4	19.1
11	103	0.8	16.3
12	93	0.6	15.3
13	83	1	16.5
14	73	1.5	17.2
15	63	0.7	16.8
16	53	0.3	16.6
17	43	1.2	18.4
18	33	1.8	16.7
19	23	1.7	15.2
20	13	0.5	14.2
21	3	0.8	15.6
