14th International Road Safety Conference

Gdańsk University of Technology, 29-31 May 2023

ROAD SAFETY INSPECTION AS A TOOL OF A PROACTIVE METHOD OF ROAD INFRASTRUCTURE SAFETY MANAGEMENT

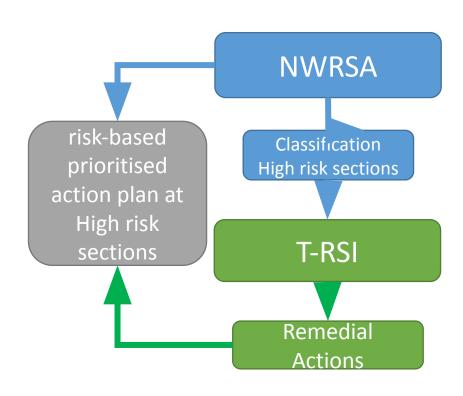
Network Wide Road Safety Assessment (NWRSA) Targeted Inspections (T-RSI) – Safety Inspections (RSI)

Comments: NWRSA is a new tool in RISM that will affect RSI procedures and results. We need to understand how NWRSA results and data can be of support to T-RSI and how RSI will complement NWRSA

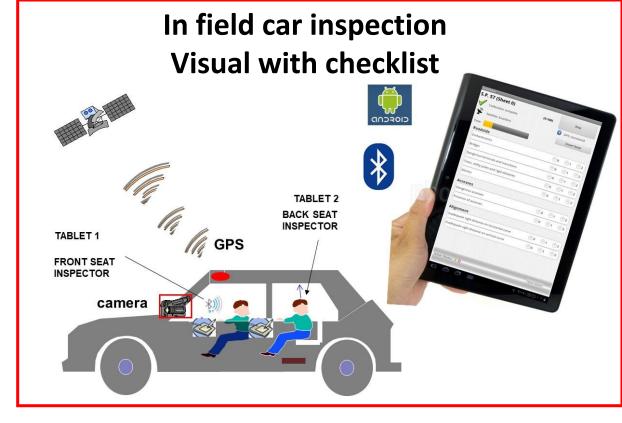
Automated data collection Virtual Inspection

Front view

Rear view

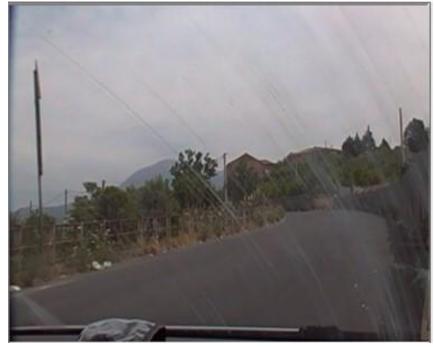
In the Office

After in field Safety Inspection, Checklists are reviewed in the office by the Inspection Team (Review software)

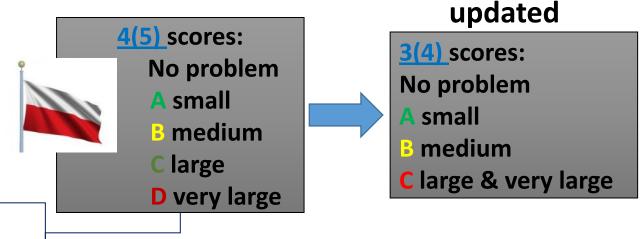
Harmonization of the two guidelines In terms of equivalent Risk factor

Polish risk category Presence of accesses Dangerous terminal vertical Dangerous accesses Trees, utility poles and rigid obstacles Inadequate sight Inadequate sight horizontal curve signs barrier reflectors Guideposts and Shoulder width Warning signs, **Embankments** Unevenness distance on distance on Lane width Safety issue Edge lanes regulation Ditches severity IASPscore В В В В В В D D В В В

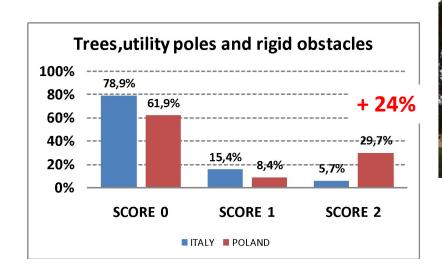
Roadside: Tree hazard

Score: HIGH

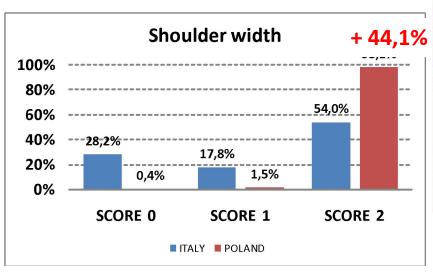
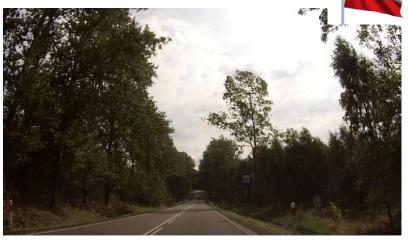
Inadequate shoulder width

Score: High

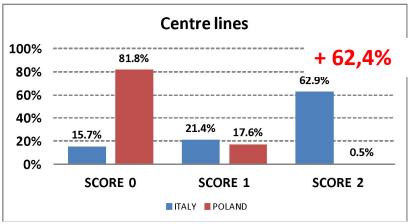
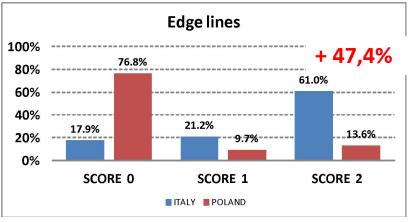
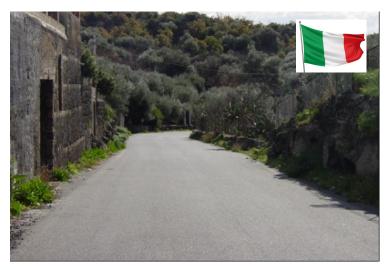
No lane marking **Score: High**

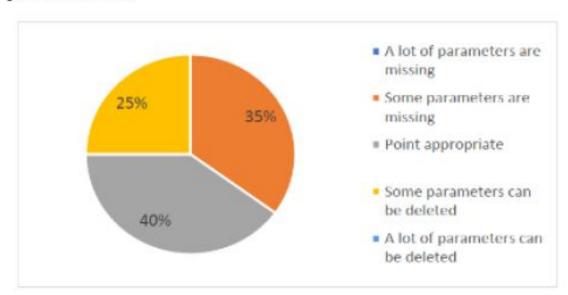
Question no.4 - How complete do you feel about the method in terms of the parameters tested?

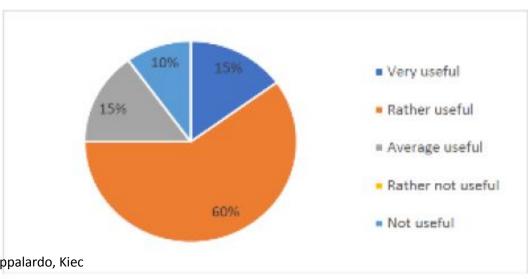
Question no.5 - How useful do you think the method is?
