VI INTERNATIONAL TUNNELING FORUM

Silkyara Tunnel Rescue **A Tale of Resilience, Innovation and Survival**

Rahul Gupta
Chief Engineer
Ministry of Road Transport & Highways
Government of India

14th May, 2024

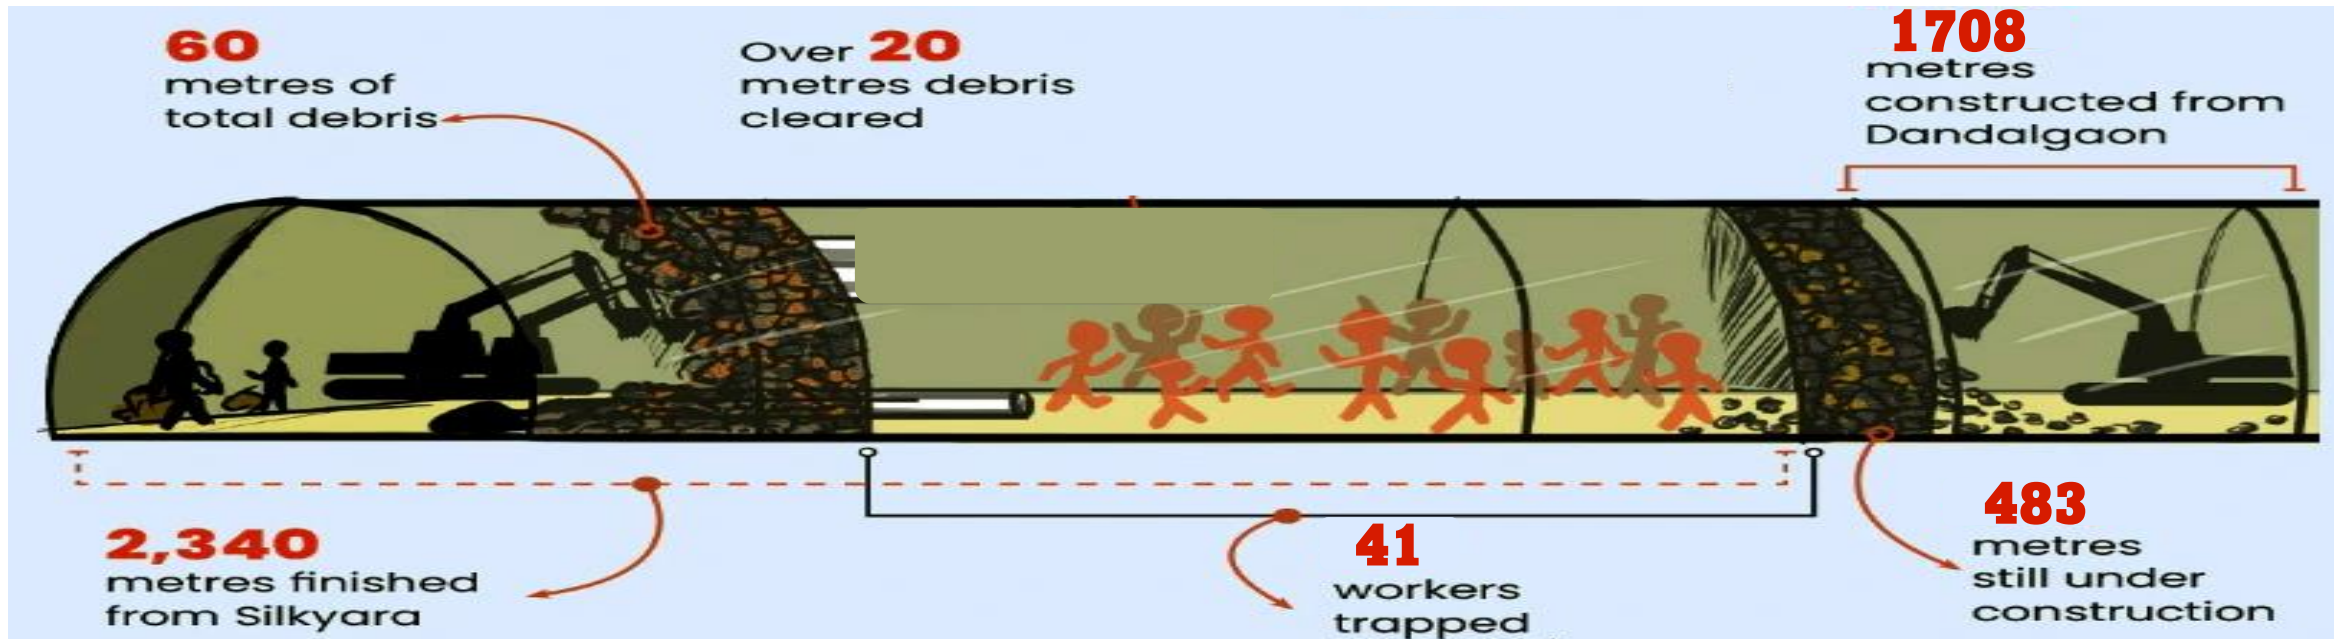
- **Date & Time** :12th November 2023 at 5:30 am,
- **Details**: 60- meter stretch collapsed on the Silkyara side.
- **Concern**: 41 people trapped in the tunnel.
- **Status of entrapped people**: Water supply & electricity available.

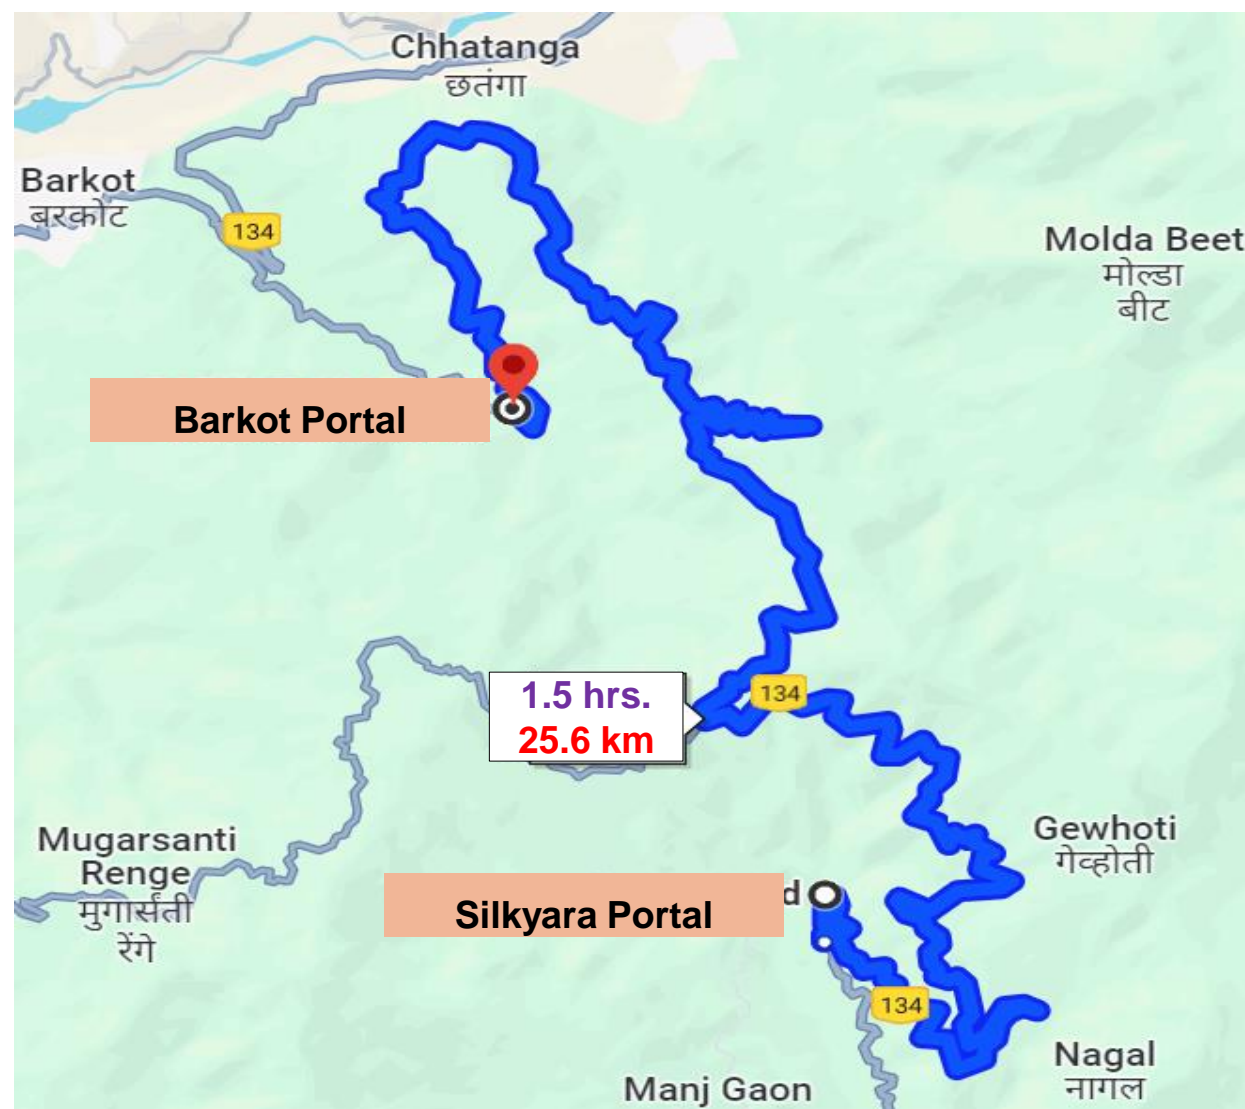
Typical Cross Section Silkiyara Tunnel

Project Stretch	2-lane Bi-Directional Silkyara Bend – Barkot Tunnel on NH-134
Project Benefit	Distance 25.6 km reduced to 4.531 km Travel time 1.5 hrs reduced to 10 mins
Project Length	4.86 Km / Tunnel- 4.531 km
Tunnel Configuration	Single tube tunnel with two lanes divided by a vertical partition wall. Excavated diameter 14 m.
Tunnelling Methodology	NATM

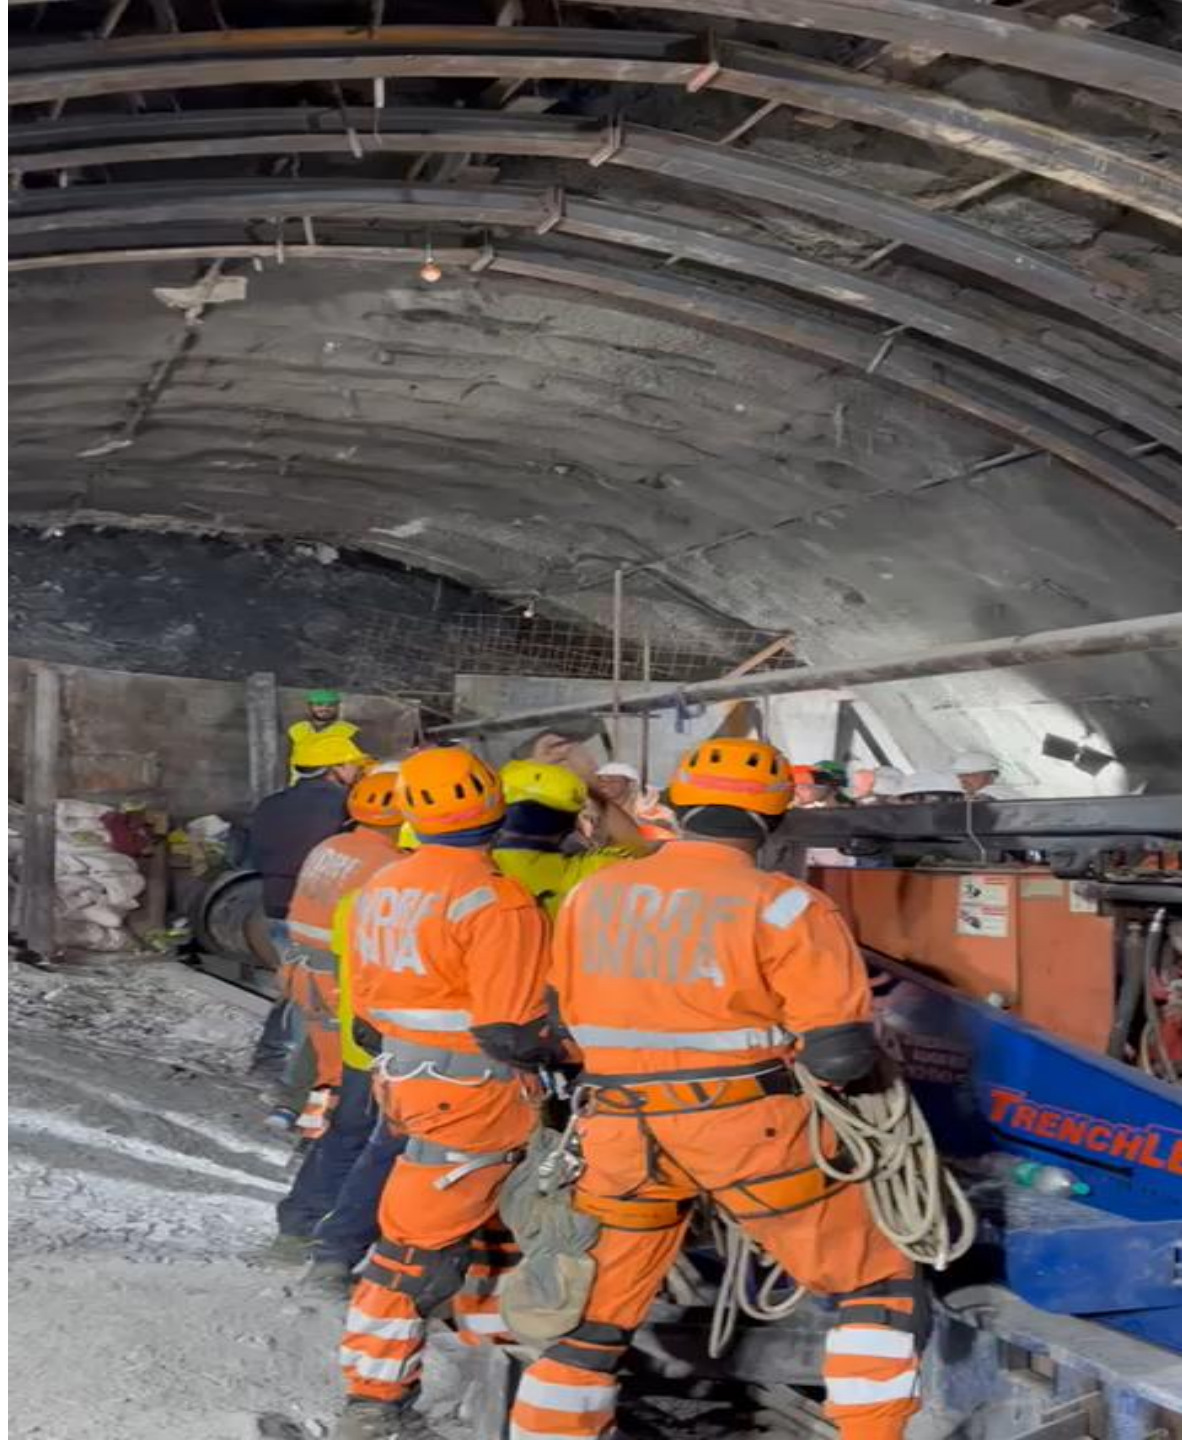
LIGHT AT THE END OF 17 DAYS: How the rescue was accomplished

After 17 days stuck inside a caved-in tunnel, 41 trapped workers were brought out as 'rat miners' cut through debris in the collapsed Silkyara-Barkot tunnel. The task, which started with excavators and then moved to large drilling machines, ended by having 12 experts crawl inside a tiny hole and cut through the last 12 metres of debris. Here, we take a look at how the final leg of the mission was carried out.
